ARTICLE

The Potential of the Vunania Dam in Sustainable Agriculture in the Kassena Nankana Municipality of the Upper East Region

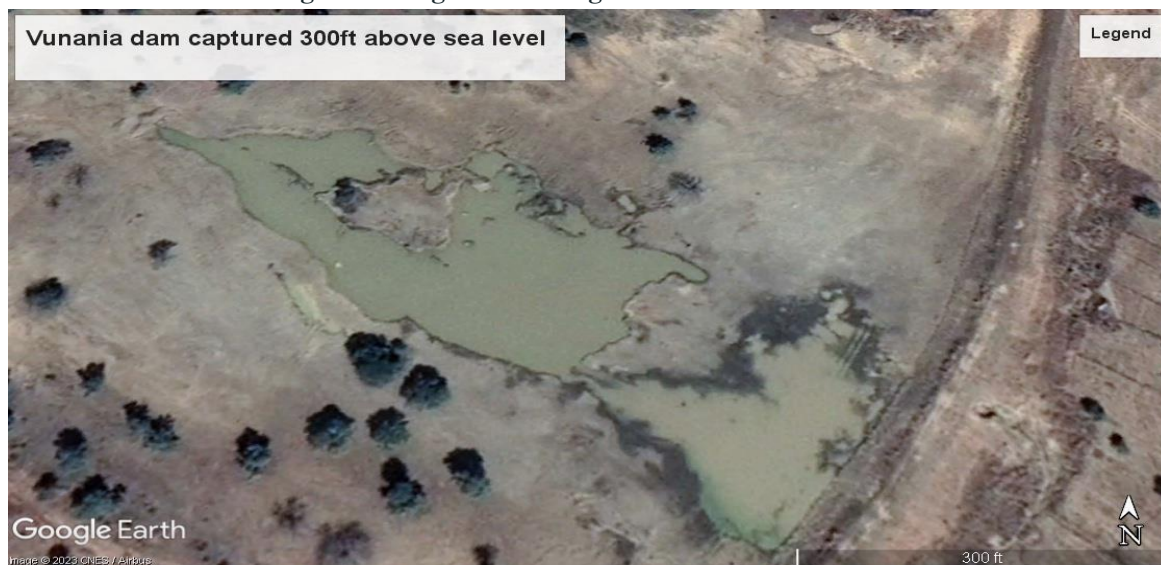
Figure 2: Google Earth Image of the Vunania Reservoir

Aerial view of the high-elevation section of the Vunania reservoir showing the impoundment area and surrounding catchment.

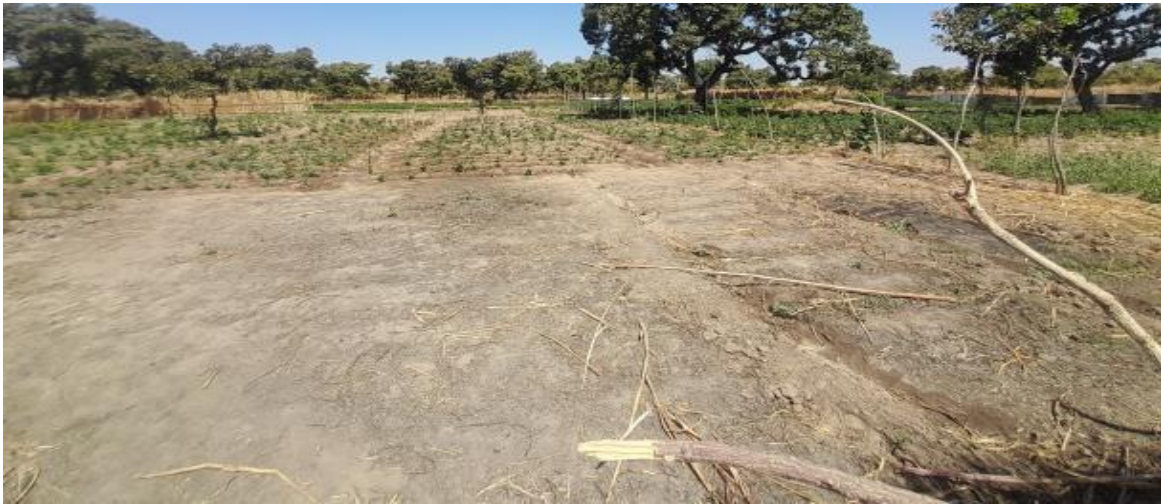
Figure 4: Farming at the Upstream Area Close to the Dam

Farmers cultivating vegetables at the upstream end of the Vunania reservoir. Proximity to the dam facilitates multi-activity livelihoods but risks sedimentation if buffer zones are not enforced.

- The 30-metre buffer zone around the reservoir should be clearly demarcated, grassed, and enforced, with GIDA providing technical support to community members in monitoring and upkeep.

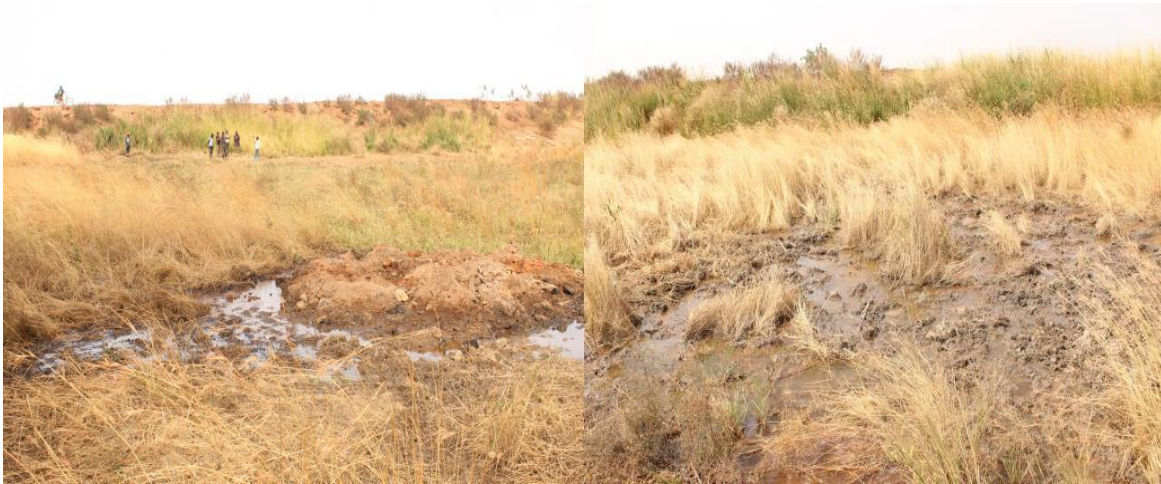
Figure 5: Water Oozing from the Ground Behind the Vunania Dam

The most concerning finding was water emerging from the ground at the downstream end behind both ends of the dam wall — clean water flowing visibly on the surface and keeping the ground wet up to a mile away. Community members attribute this to improper compaction of the embankment's foundation layers, citing direct observations during construction:

GIDA engineers, however, note that the water is emerging several metres from the toe of the embankment and is clear — not turbid as would be expected if the dam wall were actively eroding fine particles (Kazemzadeh-Parsi and Daneshmand, 2011). Their preferred explanation is either activation of dormant springs due to impoundment pressure, or water percolating through porous rock formations beneath the valley. As reservoir pressure fills these pore spaces over time, the flow may naturally reduce (Pham et al., 2013). The finding that the seeping water is within the planned irrigable area may partially offset the loss by providing natural sub-surface irrigation for downstream plot-holders.

Groundwater emerging at the downstream end of the Vunania embankment. The clarity of the water indicates percolation through porous rock rather than dam-wall erosion, but geotechnical investigation is required.

Regardless of cause, the condition requires early geotechnical investigation. Allowing seepage to continue without diagnosis risks progressive structural compromise of the embankment, particularly at the ends where both community observation and engineer inference suggest inadequate compaction (Özer and Bromwell, 2012).

- A geotechnical investigation should be completed before the end of January, when the seeping water is still at or above the diagnostic point, to determine whether the cause is dormant spring activation, porous rock percolation, or inadequate compaction — and to prescribe the appropriate remedy.

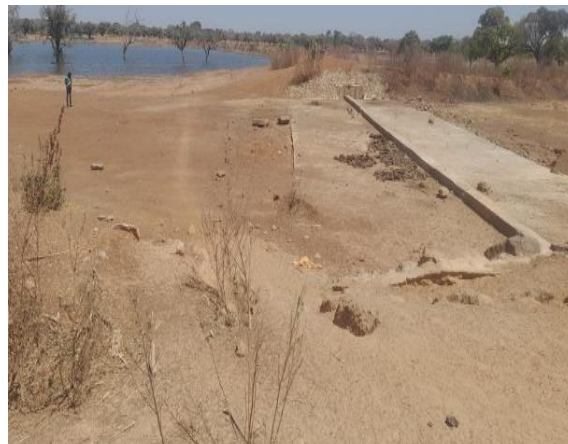
Figure 6: Spillway and High Elevation of the Impounded Area

Field observation and elevation measurements revealed an imbalance in the dam's hydraulic design. The spillway end of the impounded area stands at an elevation of 247 m above sea level, while the opposing end sits at 228 m. The embankment is also slightly low. During the second year of impoundment, floodwaters rose to near the top of the embankment, necessitating emergency breach of the spillway to release water — which has since been repaired but remains structurally high. In very wet years, overtopping is a realistic risk.

A heap of gravel on the left bank near the spillway further obstructs outflow, impeding natural drawdown to the full supply level. The relatively shallow valley depth, except near the dam wall, also increases vulnerability to evaporation. Community members and the engineers both recommend: (a) increasing embankment height, (b) levelling the gravel heap at the spillway to allow free flow, and (c) excavating the impounded basin to increase storage depth and reduce evaporative surface area.

The elevated spillway relative to the low embankment creates an overtopping risk in years of heavy rainfall. Levelling the gravel heap and raising the embankment are priority remedial works.

- The gravel heap near the spillway should be graded and levelled to allow free outflow at full supply level, reducing the risk of embankment overtopping in high-rainfall years.

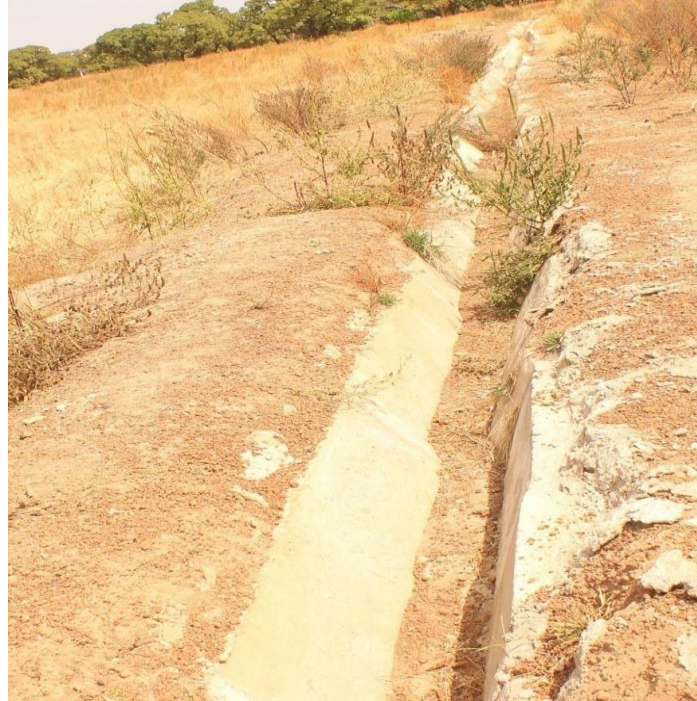
Figure 7: Canals in the Vunania Irrigation Area Showing Defective Construction

Work on the 15-hectare irrigable area downstream was underway at the time of fieldwork, but sections of the canal were broken and the alignment was irregular. Community members and the Assembly man expressed concern that construction quality mirrored the deficiencies in the dam itself:

Incomplete and misaligned canal sections in the Vunania irrigable area. Community members requested heightened GIDA supervision to ensure the irrigation facility meets intended design standards.

- The contractor should be required to return and address the three identified structural deficiencies: the seepage condition (following geotechnical diagnosis), the embankment height deficit, and the canal misalignment and breakages.
